HIGH TEMPERATURE STRENGTH CHARACTERIZATION OF SINTERED
ALPHA SILICON CARBIDE(U) FORD MOTOR CO DEARBORN MI
CERAMIC MATERIALS DEPT R K GOVILA OCT 82

High Temperature Strength Characterization of Sintered Alpha Silicon Carbide

REPORT FOR THE PERIOD
April 1, 1980 - December 31, 1981

R. K. Govila
Ceramic Materials Department
Scientific Research Staff
Ford Motor Company
Dearborn, Michigan

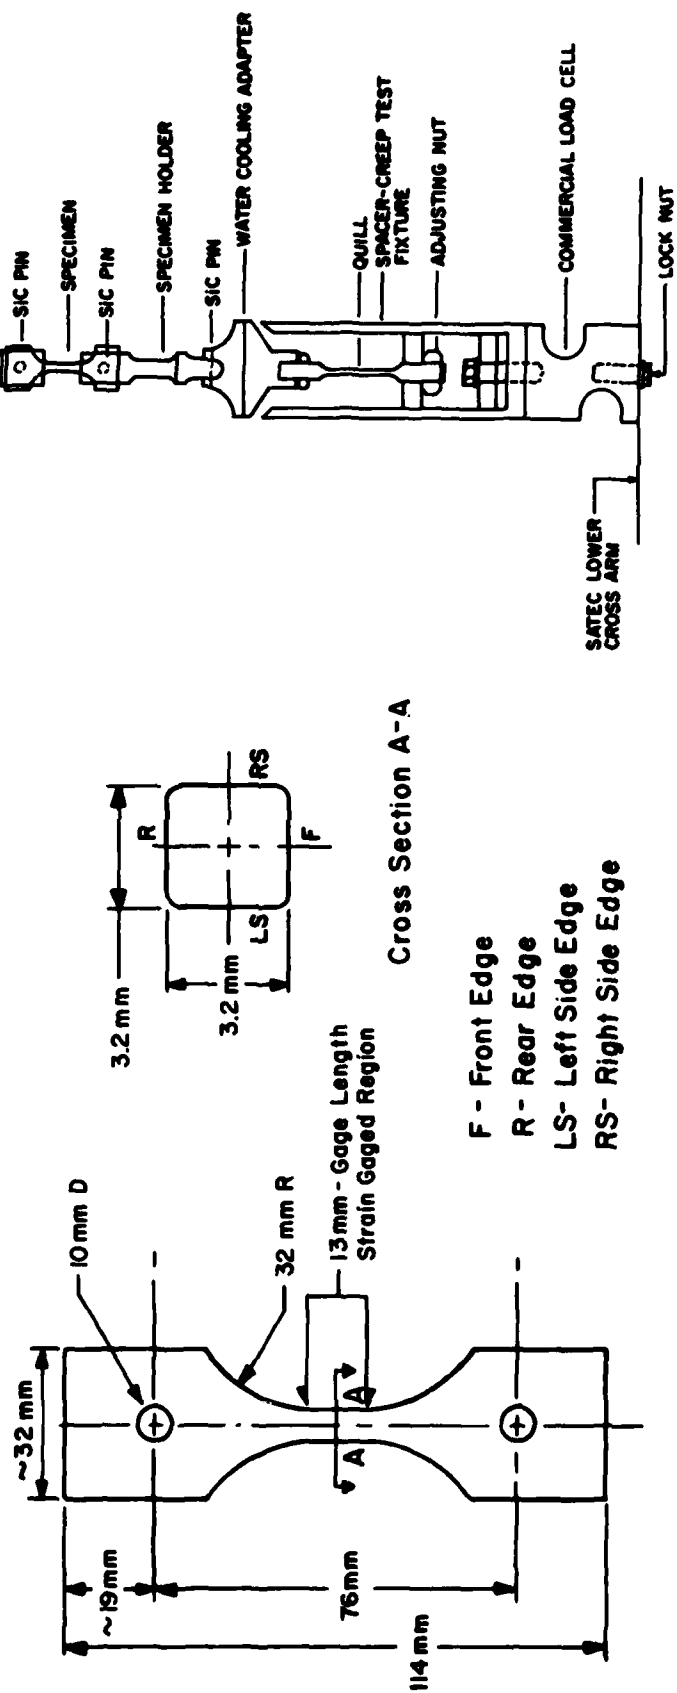
Fig. 1 (A) Geometry and dimensions of tensile stress rupture specimen.
(B) Schematic of load train assembly for tensile stress rupture testing at high temperatures.

The tensile stress specimen consisted of a simple rectangular geometry with a narrow cross-section in gage length and large radii at the shoulders necessitated by the sensitivity of ceramic materials to stress concentrations. The specimen geometry and dimensions are shown schematically in Fig. 1(A). This geometry was selected rather than a circular cross-section to facilitate machining. In the gage length, the 90° corners were hand ground (with diamond paste) to a smooth curvature to minimize stress concentrations (as shown in cross-section A-A, Fig. 1(A)). The fracture face of the lower half of each broken specimen was examined metallographically and the edges of the fracture face were identified in a fashion shown in the cross-section A-A, Fig. 1(A). This procedure also helped in identifying whether the fracture initiation sites were random or preferential.

A standard creep testing machine (Satec Systems, Inc., Groove City, PA 16127) with a modified load train assembly was used for tensile stress rupture testing. The test specimen is retained in two slotted SiC holders by large SiC

pins. The SiC holders are retained in water cooled metal adaptors which in turn are attached to the standard Satec machine head which includes crossed (90°) knife edges. The assembly procedure includes hanging the load train parts from the Satec machine head as influenced by gravity. At this point the lower Satec cross-arm is lowered to load the train in this position. The load train assembly is shown schematically in Fig. 1(B). A high temperature furnace capable of reaching 1400°C is mounted on the side of the Satec machine and encloses the full area between the water cooled metal adaptors, Fig. 2. The temperature is controlled and monitored separately with the use of two Pt - 13% Rh thermocouples placed behind the test specimen. Complete details regarding the load train instrumentation, continuous monitoring of applied stress, test temperature and time are given in an earlier study³ done on hot-pressed silicon nitride (NC-132 Si_3N_4).

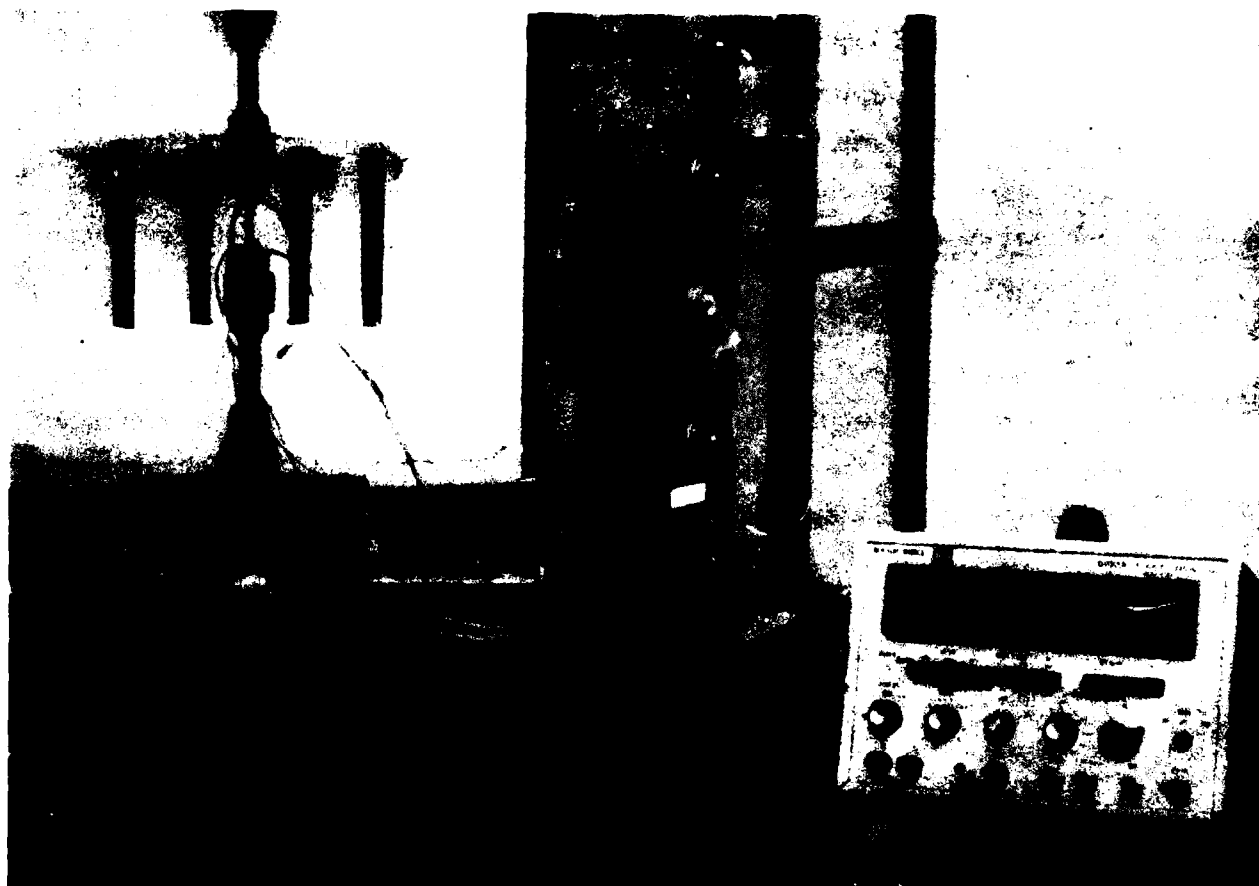
Fig. 2 A partial view of the test set-up showing the furnace, strain-gaged specimen, strain indicator and lower part of the load train assembly.

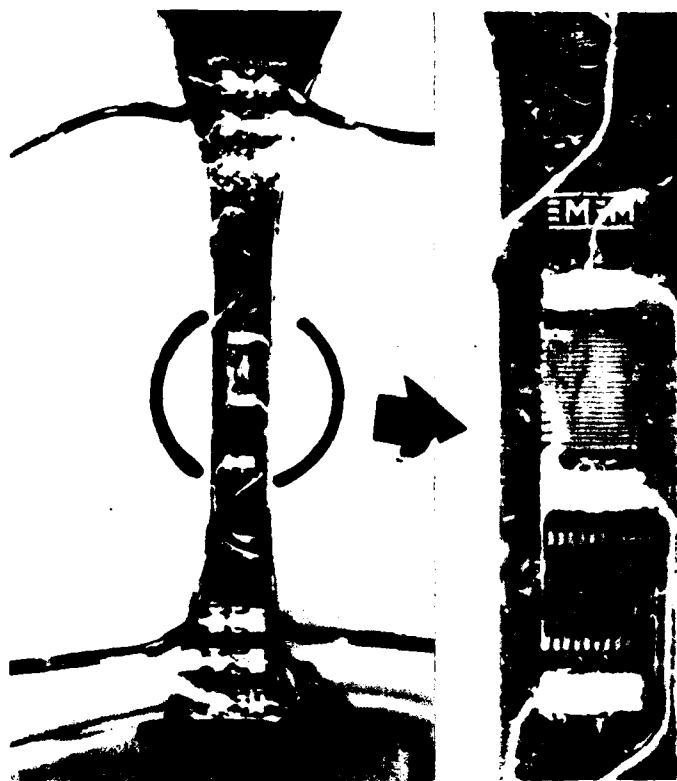
Fig. 3. Typical tensile stress rupture test specimen with strain gages attached to the gage length.

Each test specimen contained a total of eight strain gages (two on each face in the gage-length area) which, for each test, were used for custom axial alignment to keep the bending stresses below 5% at full load. Initial alignment of the specimen is done at 20°C with full load. A typical specimen with strain gages attached in the gage section is shown in Fig. 3. After alignment at 20°C , the lead wires of the strain gages are cut and either the gages are left on the specimen to burn out at high temperatures or the strain gages are peeled off the specimen surface. During this time full load is maintained on the specimen.

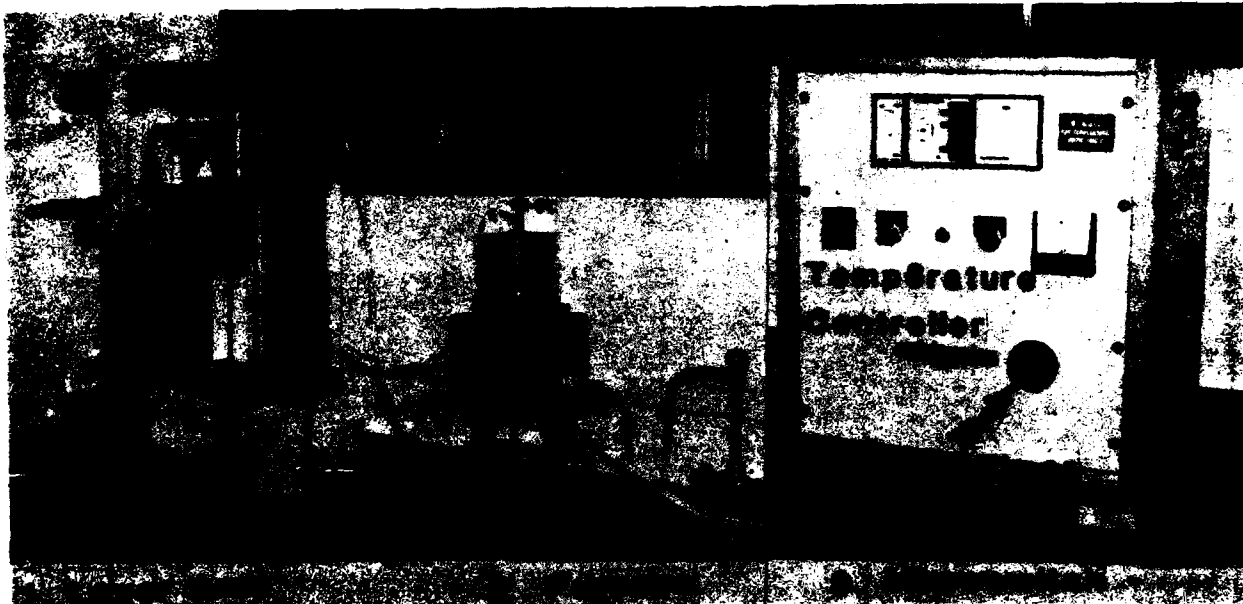
Fig. 4 An overall view of the flexural stress rupture test set-up.

The flexural stress rupture tests at high temperatures (1200° to 1400°C) were also conducted in four-point bending using the aforesaid ceramic fixture and high temperature furnace. The load is applied on the test specimen through

a cantilever arm dead-weight assembly. The experimental set-up is equipped with a microswitch to cut-off power supply to the furnace and the timer at the instant failure of the specimen occurs and the total time-to-failure is recorded through the timer in the power control unit. The temperature is allowed to stabilize for a minimum of 30 minutes before full load is applied to the test specimen. An overall view of the test set-up is shown in Fig. 4. Several tests were also conducted in a partial inert gas (Argon) environment. Argon gas was passed in the high temperature furnace chamber (150mm x 150mm x 200mm) at the rate of 10 CFH (cubic feet per hour) with a positive pressure. This method simply reduces oxidation effect to a lesser degree and does not eliminate completely.

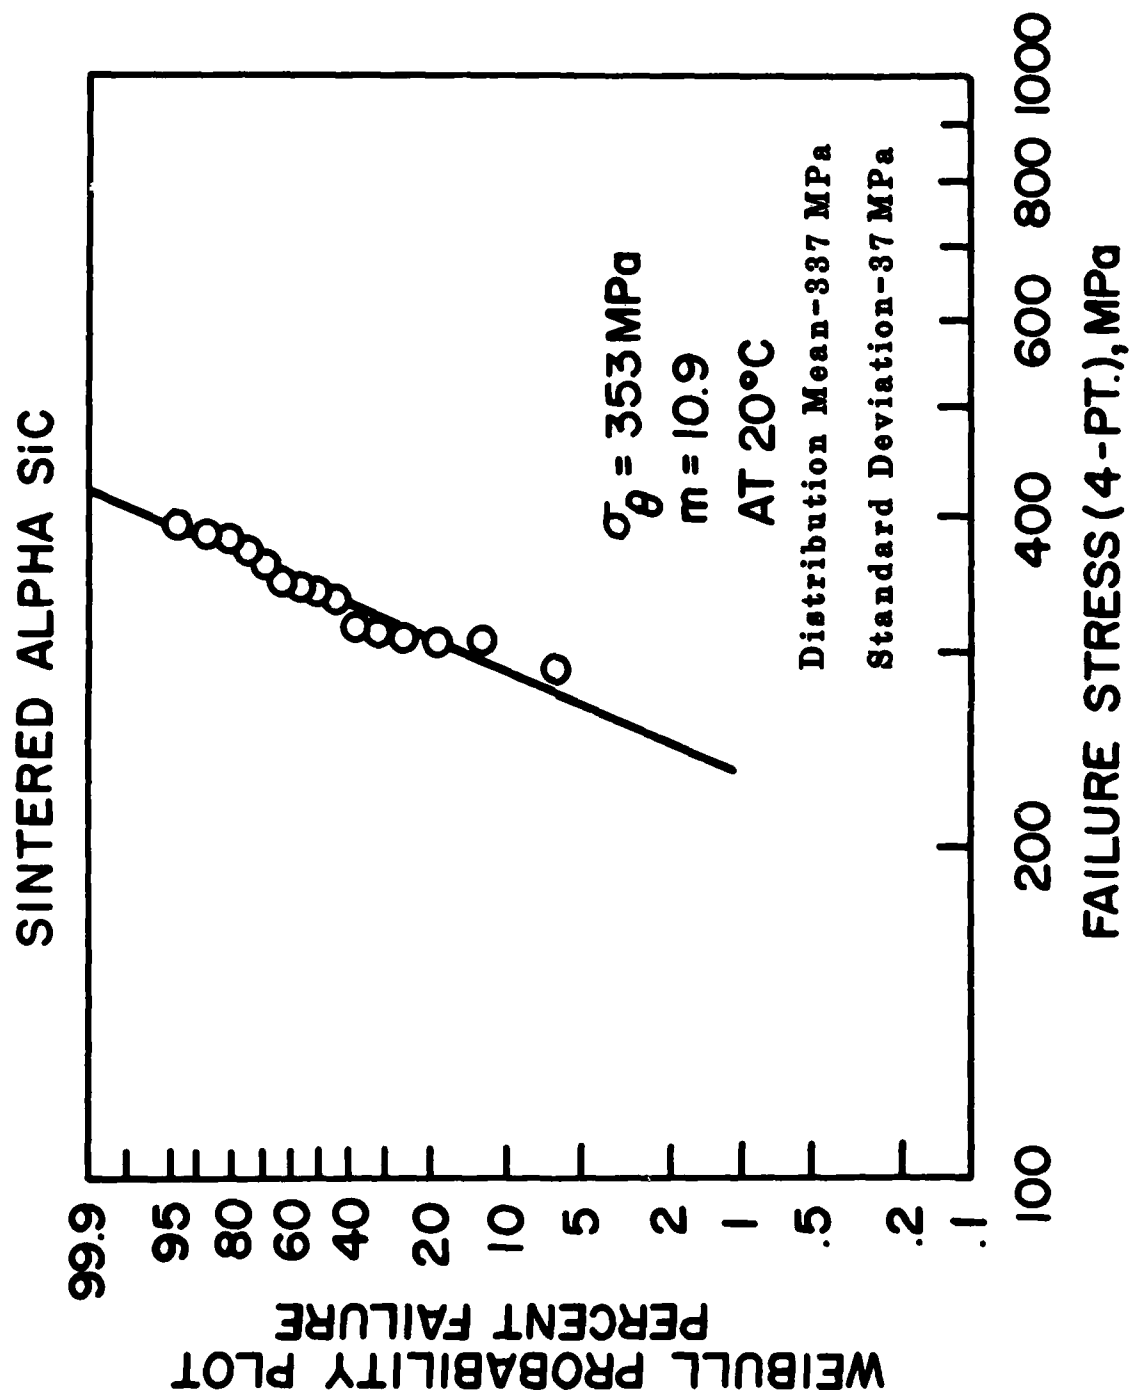
Fig. 5 Statistical variation in fracture strength.

percent of the population (specimens) will fail and the Weibull modulus, m , is a measure of shape and distribution of flaws in the material. The statistical variation in fracture strength (σ_F) (Weibull Probability Plot) at 20°C is shown in Fig. 5. A large scatter in σ_F is evident as indicated by a low value of Weibull modulus $m \approx 11$. The σ_F varied from a minimum of 289 MPa to a maximum of 390 MPa with a distribution mean of 337 MPa and a standard deviation of 37 MPa. Two types of porosity was observed in the bulk material on the fracture faces of specimens, Fig. 6; (i) Fine pores usually of the size 0.5 to 3 μm distributed uniformly along the grain boundaries. (ii) Large pores usually of the size 20 to 80 μm . Majority of the failures showed surface related failure initiation sites as typically shown for test specimen #5 in Fig. 7, but occasionally sub-surface failure origins were also observed as seen later. Occasionally, multiple failure origins along the tensile edge of the fracture face (where maximum stress occurs) were also observed, Fig. 8. It is possible that the small pores in the material opened-up due to surface machining damage. In room temperature tests, all fracture faces showed a smooth appearance characteristic of fast fracture similar to cleavage of ionic single crystals and this type of failure is characterized by transgranular crack propagation.

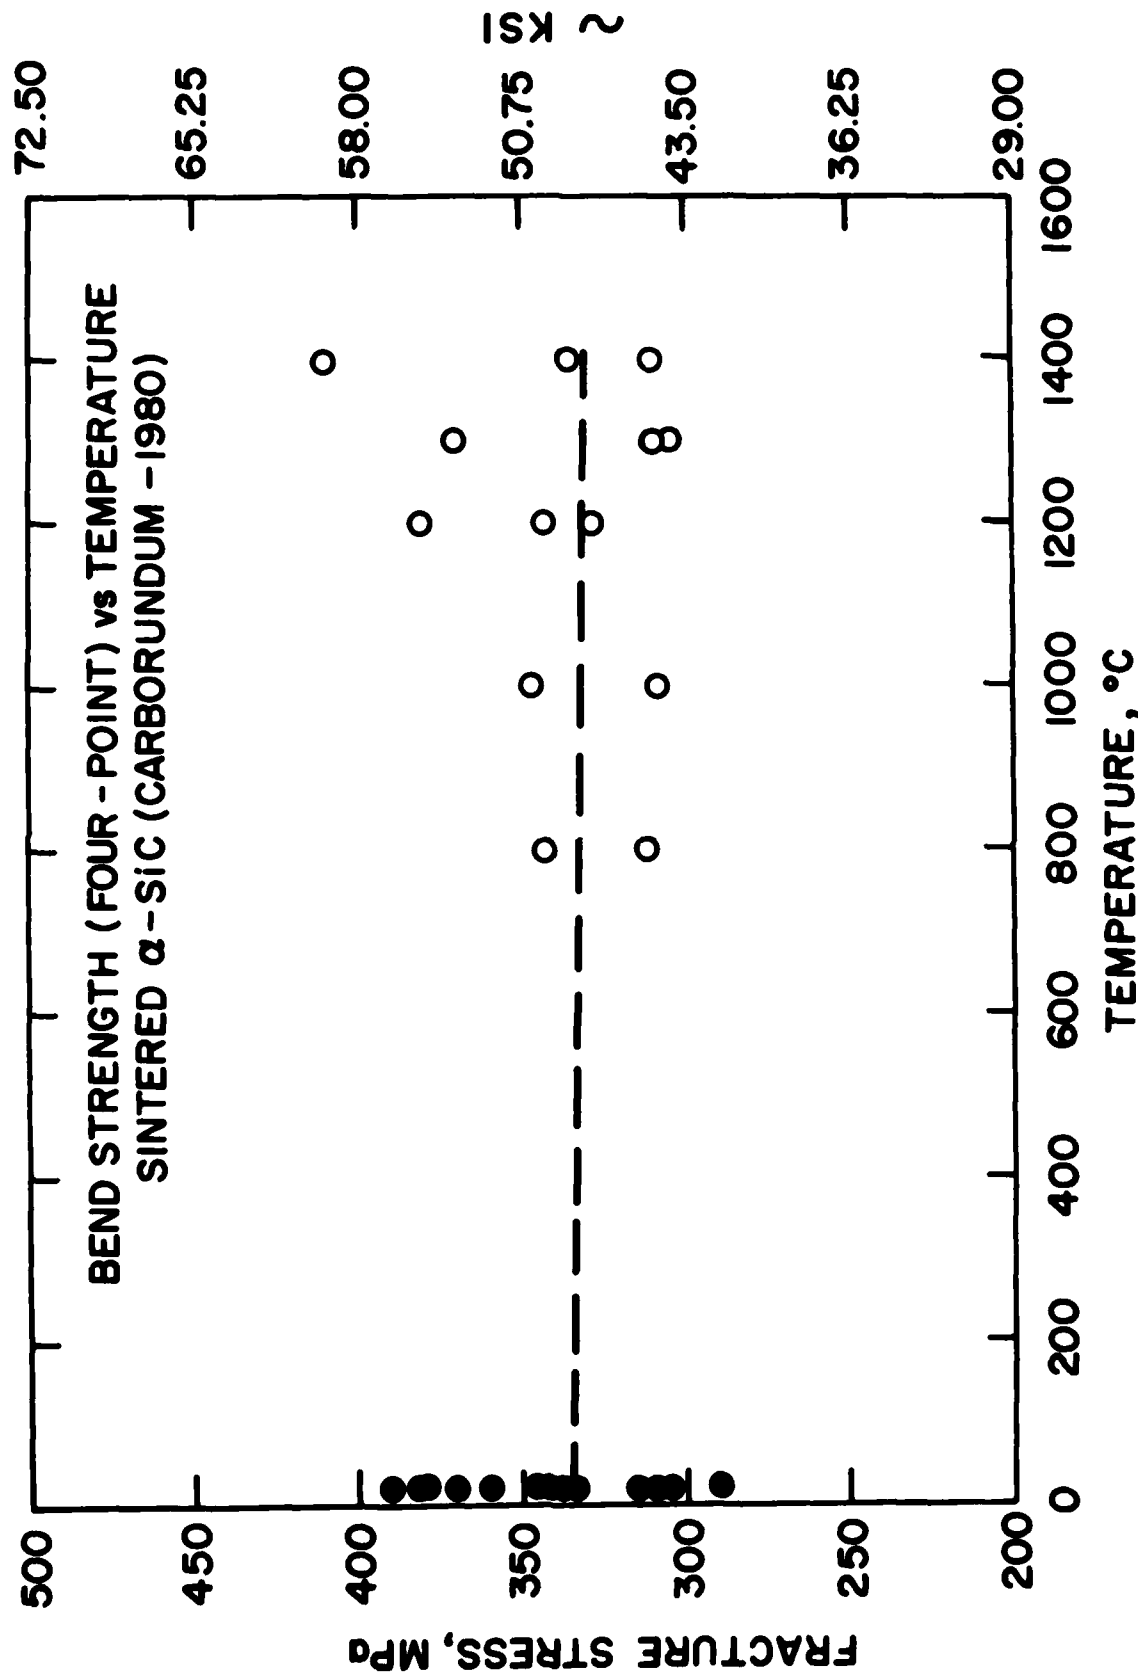
Fig. 9 Variation in fracture strength as a function of temperature.

Flexural strength was also evaluated at higher temperatures (800° to 1400°C) in order to determine if any plastic deformation accompanied the fracture process and if any of these flaws seen in fast fracture (20°C) grow slowly or subcritical (slow) crack growth (SCG) occurs. The data are given in Table I and the variation in fracture strength as a function of temperature is shown in Fig. 9. There is some scatter in the data but the fracture strength, σ_F , for as-machined specimens essentially remains constant and independent of temperature from 20° to 1400°C. The constancy of σ_F suggests that no change in fracture mechanism occurs and indicates the absence of plastic deformation and slow crack growth. This was confirmed by the appearance of the fracture surfaces at higher temperatures (1200° to 1400°C) similar to that observed at 20°C. Typical fracture surfaces in which failure origin was located at the tensile surfaces at 1200°, 1300° and 1400°C are shown in Figs. 10, 11, 12, respectively. Note the random distribution of fine porosity along the grain boundaries in the bulk material (Figs. 10(b), 11(b), 12(b)) and the fracture face appearances are similar to that observed at 20°C (cf. Figs. 10-12 and Figs. 6-8). Also, the failure origin sites in every case (especially true for fast fracture)

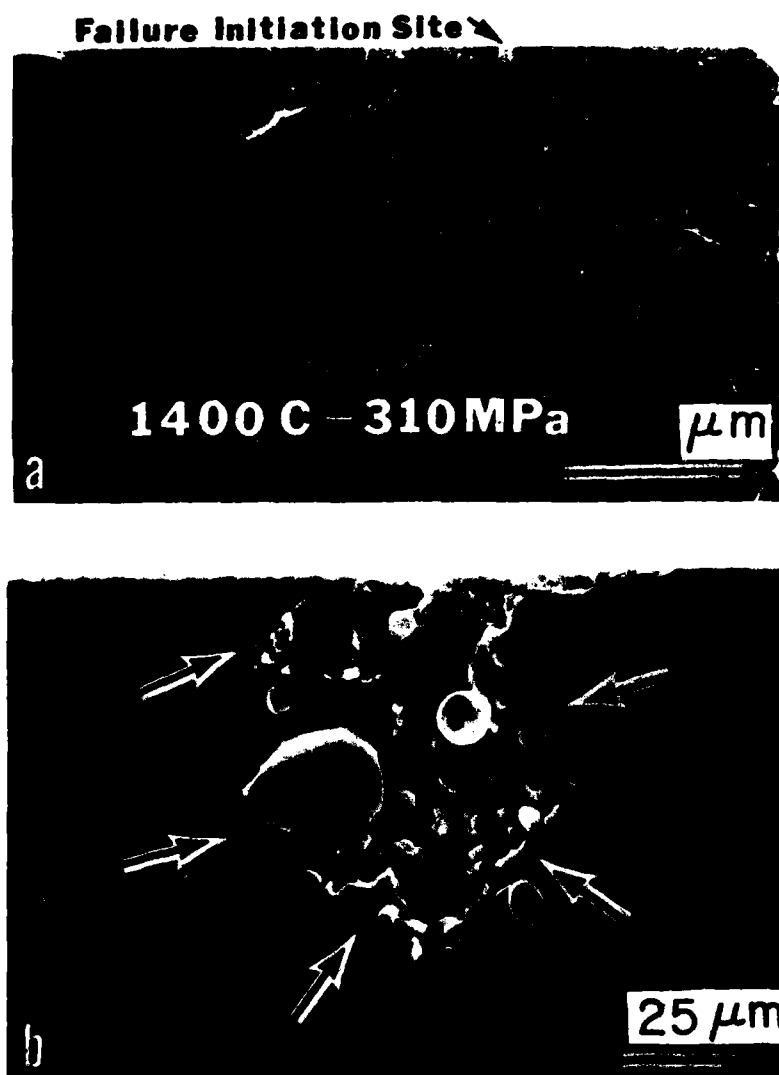
Fig. 12 SEM micrographs of the fracture surface of a specimen (sintered α -SiC) tested in 4-pt. bending at 1400°C in air showing surface associated failure site. Fracture mode is primarily transgranular and no sign of any slow crack growth.

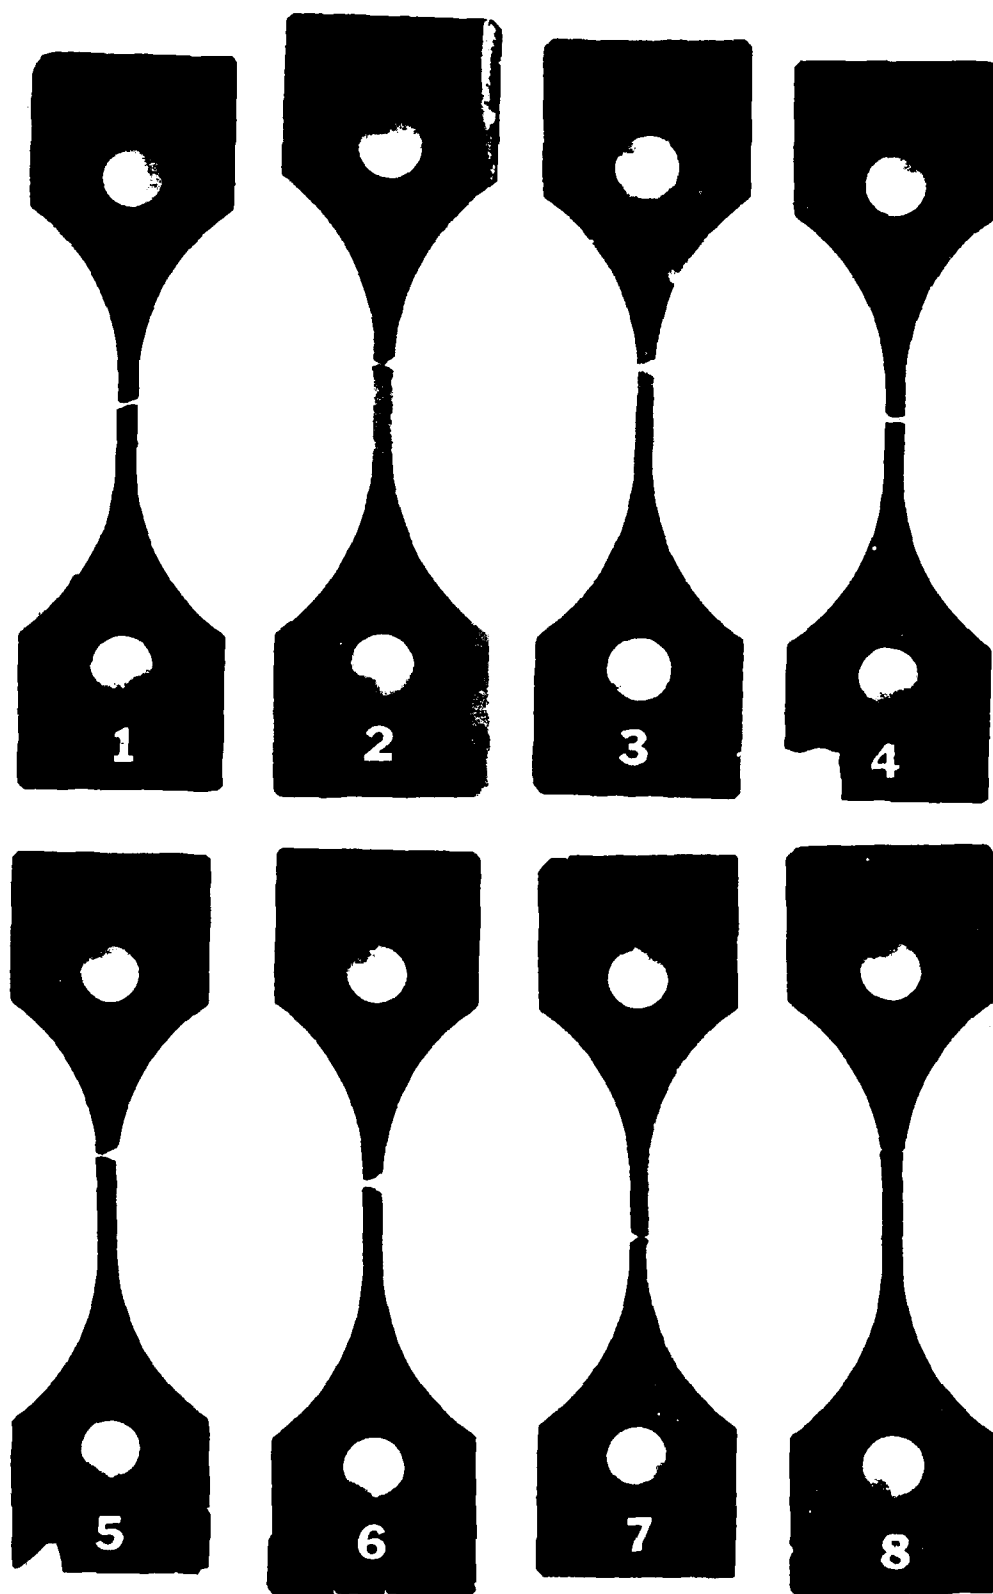
Fig. 15 Typical appearance of the broken specimens of sintered α -SiC tested at 1200°C in air in uniaxial tensile stress rupture model (see Table II for results).

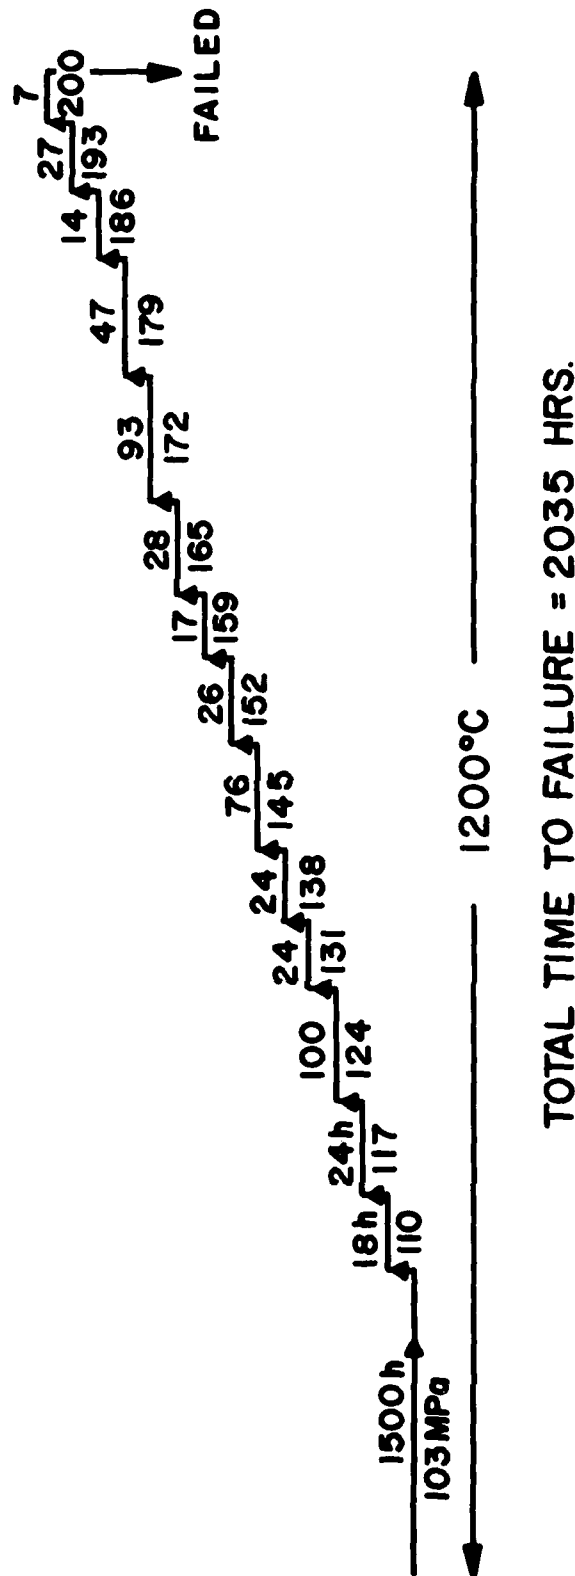
Fig. 16 Schematic illustration of the stepped stress rupture testing in uniaxial tension for sintered α -SiC specimen #1 (Table II). Initially the specimen was subjected to an applied stress of 103 MPa and sustained the stress for 1500 hrs. without failure. The applied stress was increased gradually as shown above and finally the specimen failed after 7 hrs. at 200 MPa. Fracture surfaces of both (bottom and upper) halves are shown in Figs. 17 and 18, respectively.

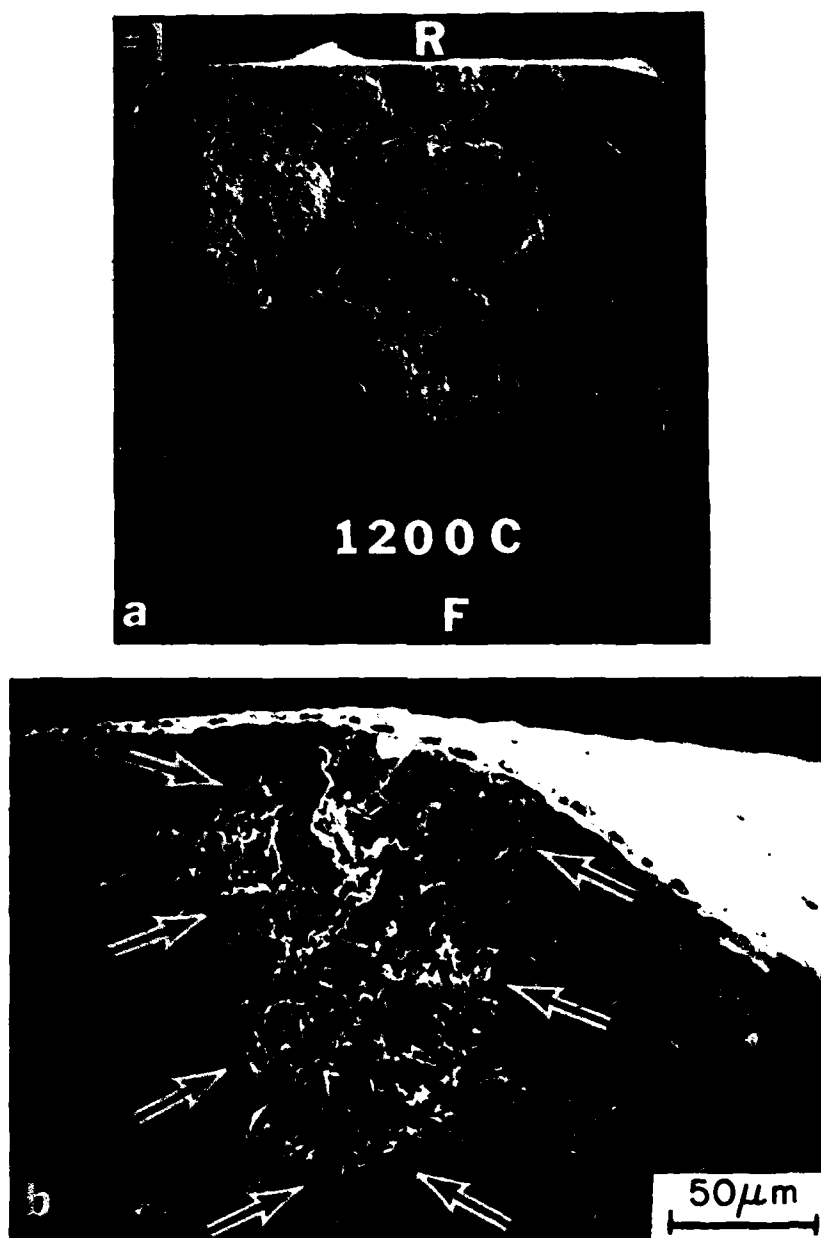
Fig. 17 Overall view of the fracture surface (bottom half) as seen in SEM of tensile stress rupture specimen (#1, Table II) of sintered α -SiC tested at 1200°C in air. (a) Failure site as indicated. (b) Failure region is distinct in appearance from the remainder of the fracture surface and shows limited slow crack growth. Separation of grains due to intergranular crack propagation is visible.

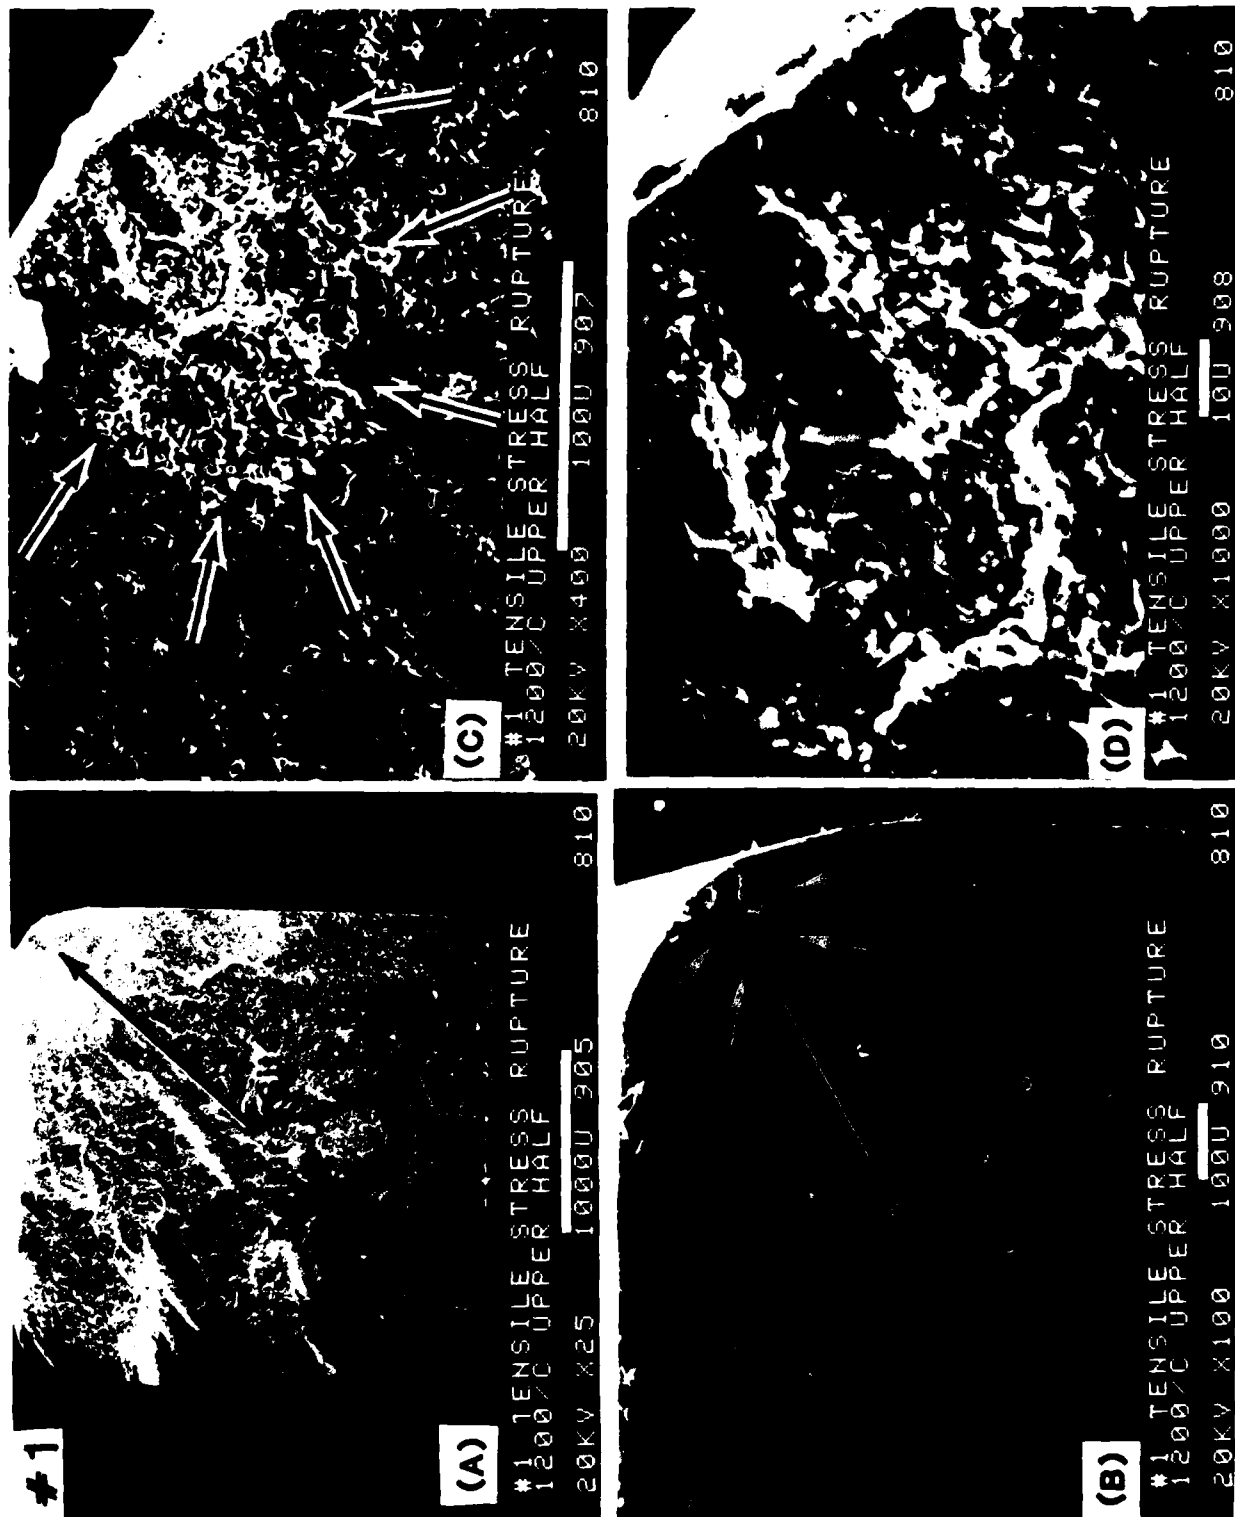
Fig. 18 SEM micrographs of the fracture surface (upper half of failed specimen) of specimen #1 showing failure site and the associated region of slow crack growth. Note the separation of grains along the grain boundaries inside the subcritical crack growth region clearly indicates that crack propagation during slow crack growth is primarily intergranular.

and (D)). The failure site is essentially a small slow crack growth (SCG) region surrounded by fast fracture region, Fig. 18(B). Since the specimen survived for a considerable long time, it is unlikely that failure started due to any machining damage around the rear right corner.

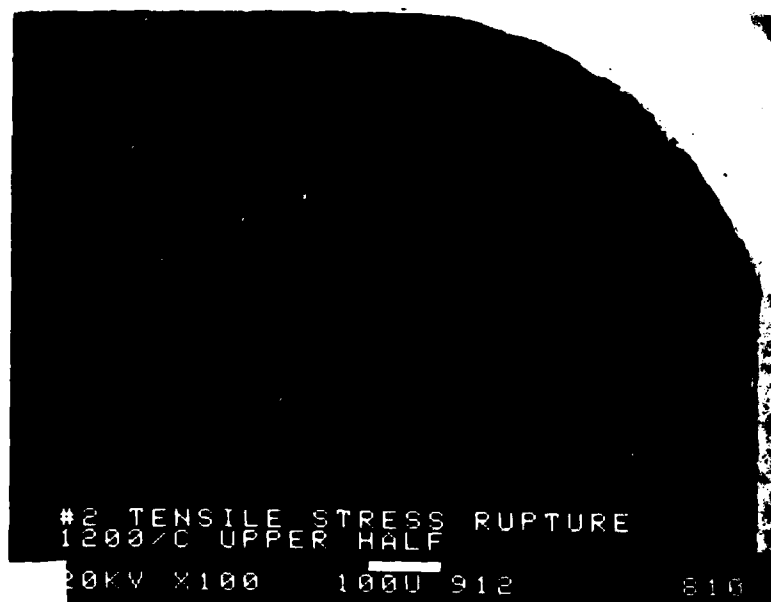
Fig. 21

SEM micrographs of the fracture surface of tensile stress rupture specimen #3 showing failure site and the associated damage surrounding it.

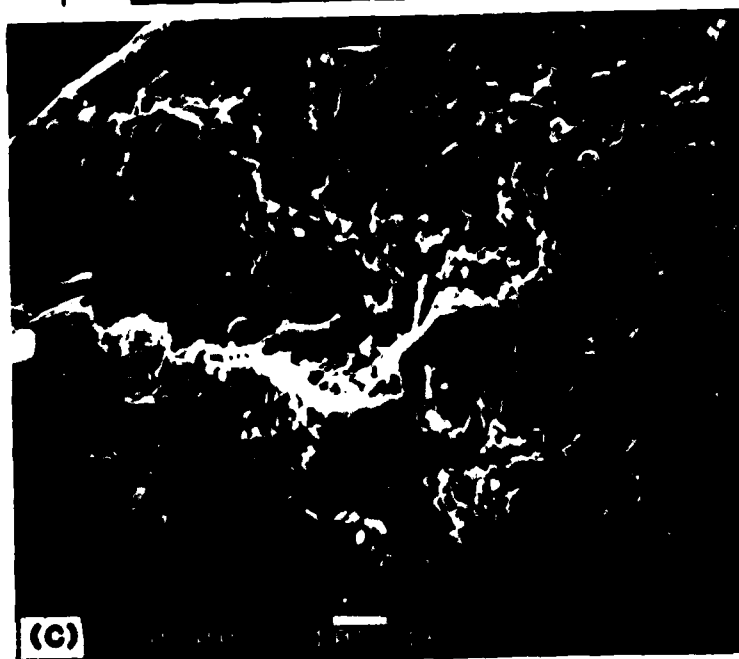
Fig. 22
SEM micrographs of the fracture surface of tensile stress rupture specimen # 4 showing failure initiation site, porosity and limited slow crack growth.

The next specimen was tested at an applied stress of 207 MPa (30,000 psi) and failed after 447 hrs., Fig. 22. The failure region is clearly visible as shown in Figs. 22(A-B) and limited SCG is also evident inside the failure region, Fig. 22(C). Occasionally, failure occurring at an inclusion or foreign particle was observed, Fig. 23, and in such cases the time-to-failure was short (< 1 hr.) and fracture surface showed smooth appearance characteristic of fast fracture (transgranular crack propagation), Fig. 23(C).

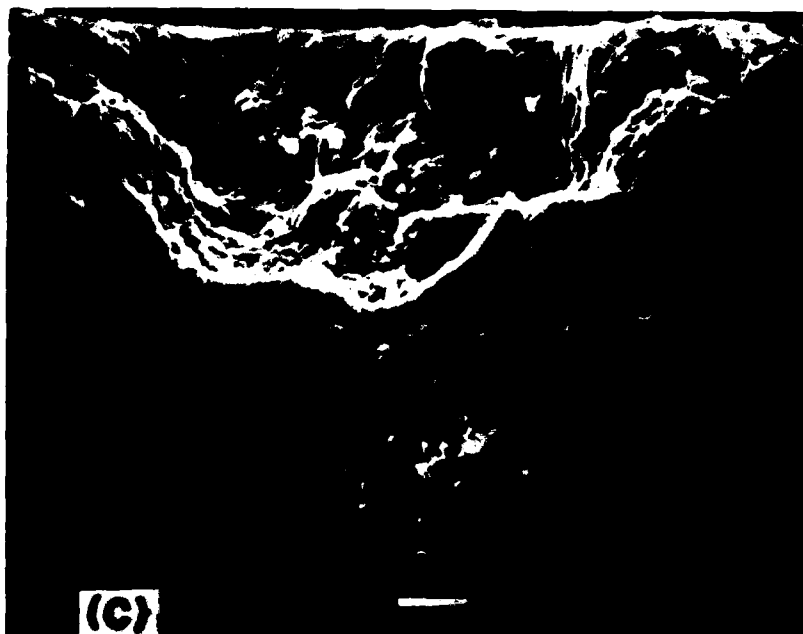
Fig. 24

SEM micrographs of the fracture surface of tensile stress rupture specimen #6 showing possible machining damage leading to fast failure. No visible SCG.

The evidence of machining damage leading to early failure (short time-to-failure) was clearly evident in specimens #6 and #7, subjected to an applied stress of 241 MPa (35,000 psi) which failed in 45 mins. and 4 hrs., respectively. The fracture faces are shown in Figs. 24 and 25, respectively. Specimen #6, Fig. 24, shows clearly a notch effect (localized stress concentration) possibly produced by machining which opened up porosity (loosening of grains), Fig. 24(C) and led to early failure (fast fracture). Specimen #7, Fig. 25, basically

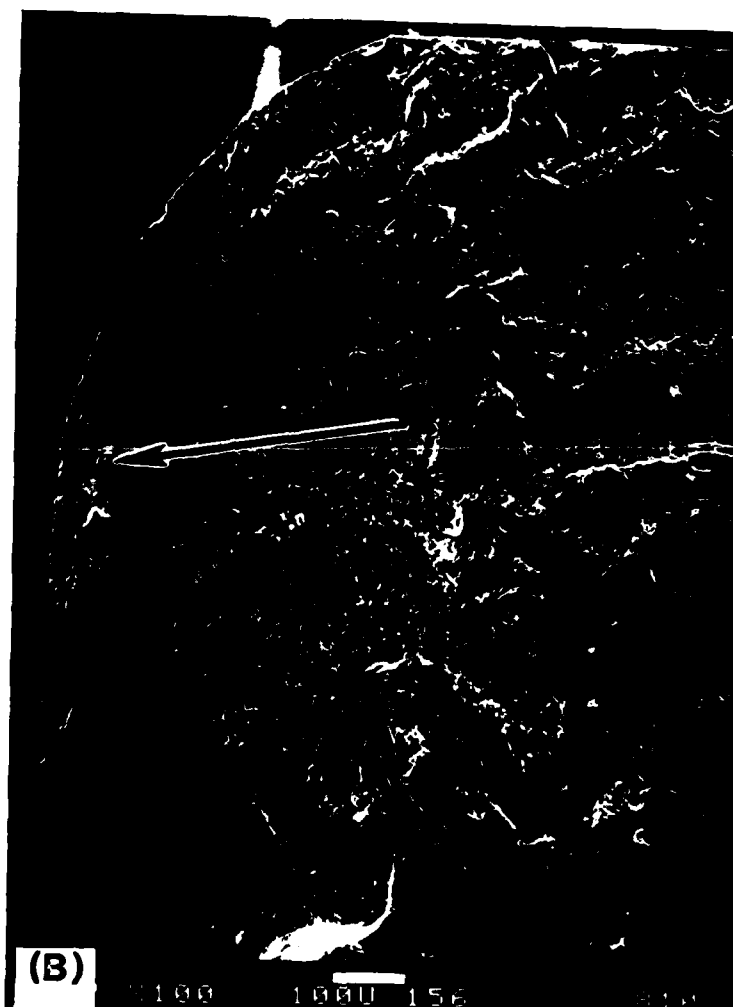
Fig. 25 SEM micrographs of the fracture surface of tensile stress rupture specimen #7 showing possible machining damage leading to early failure. No visible SCG.

showed the same behavior as #6 (Fig. 24) except machining damage does not appear to be as severe, (cf. Figs. 24(C) and 25(C)), and therefore the time-to-failure was slightly longer (4 hrs.). Both specimens showed the absence of SCG.

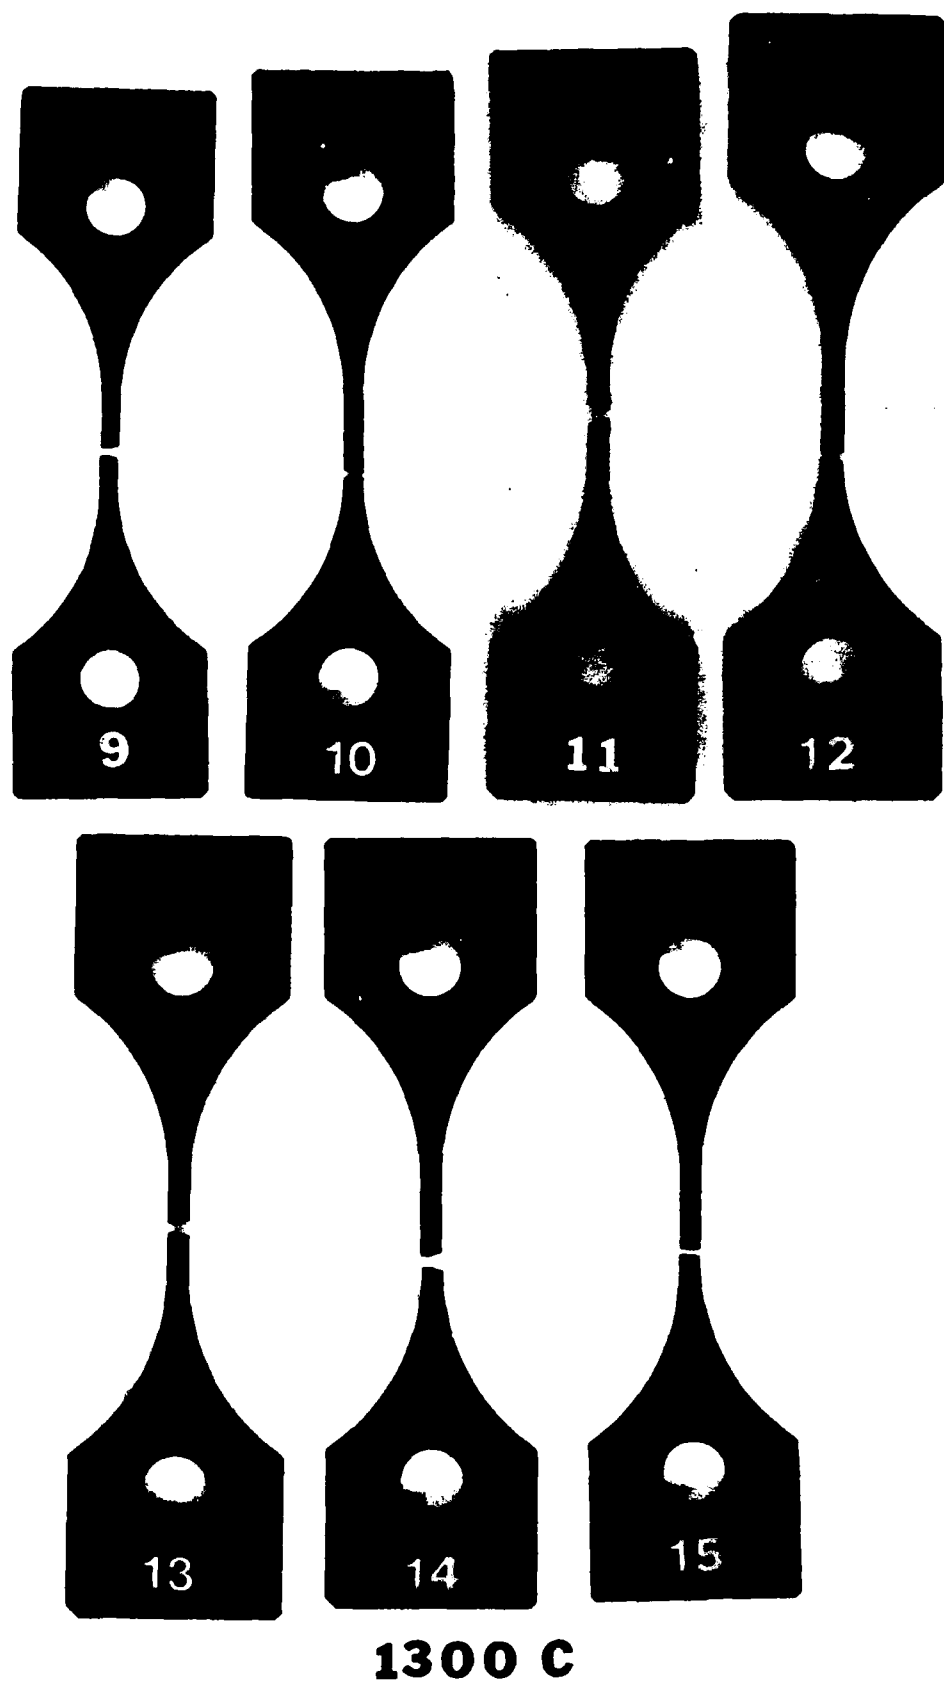
Fig. 27 Typical appearance of the broken specimens of sintered α -SiC tested at 1300°C in air in uniaxial tensile stress rupture mode (see Table II for results).

Eight (8) specimens were tested in uniaxial tensile stress rupture mode at 1300°C in air at various applied stress levels. The results are given in Table II and the broken specimens are shown in Fig. 27. Among these tests, one test specimen failed during axial alignment (at 207 MPa) at 20°C and is therefore, not listed in Table II. The first specimen (#9) tested at 1300°C was subjected to an applied stress of 172 MPa (25,000 psi) and failed in the center of the gage length after 171 hrs. Examination of the fracture face revealed that the failure initiation site consisted of a large semi-circular region of SCG, Fig. 28. The SCG region was surrounded by a mirror region. Inside the SCG zone, a large void (0.080mm long) was present. The large void became the localized stress concentration site and led to early failure. Therefore, another specimen

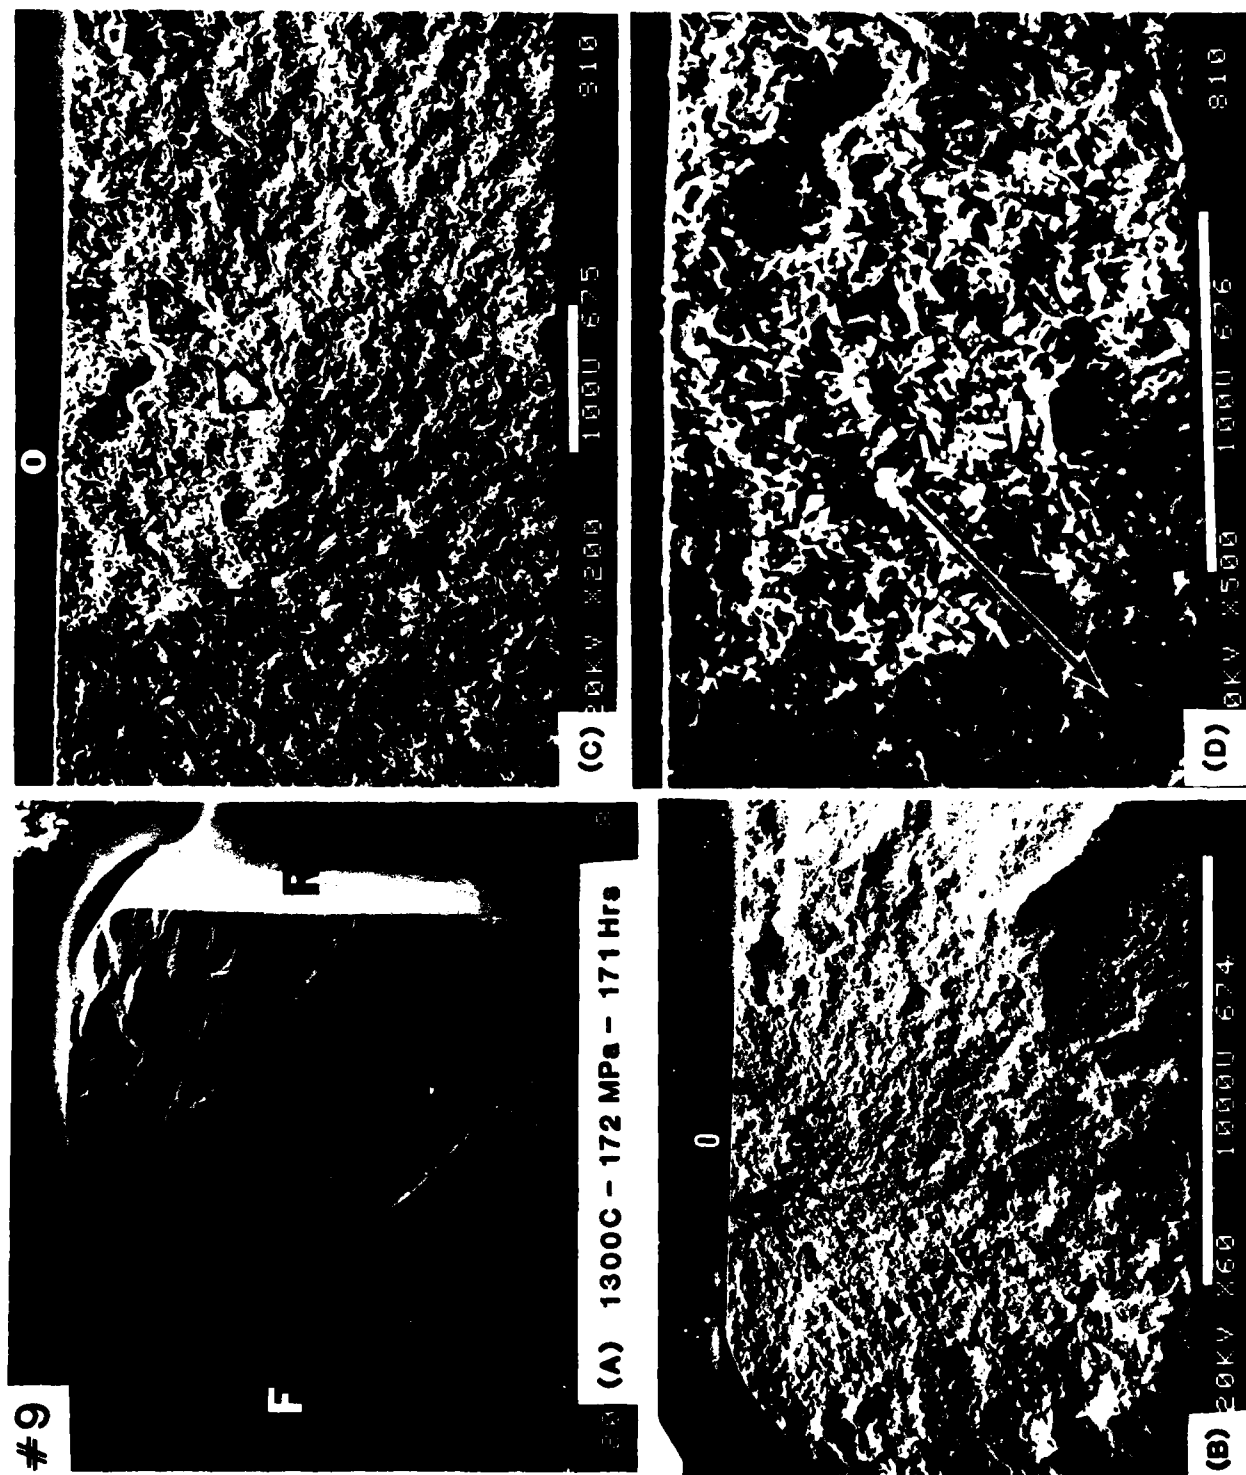
Fig. 28 SEM micrographs of the fracture surface of specimen #9 tested at 1300°C in air at an applied stress of 172 MPa and failed after 171 hrs. (A-B) Failure site is distinct in appearance and appears to be a zone (ACB) of slow crack growth region. (C) Large pore inside the SCC region. (D) Transition from SCC region to fast
